**FINAL REPORT**

**Demonstration of ECDA Applicability and  
Reliability for Demanding Situations**

**DOT Prj#195**

Gas Technology Institute

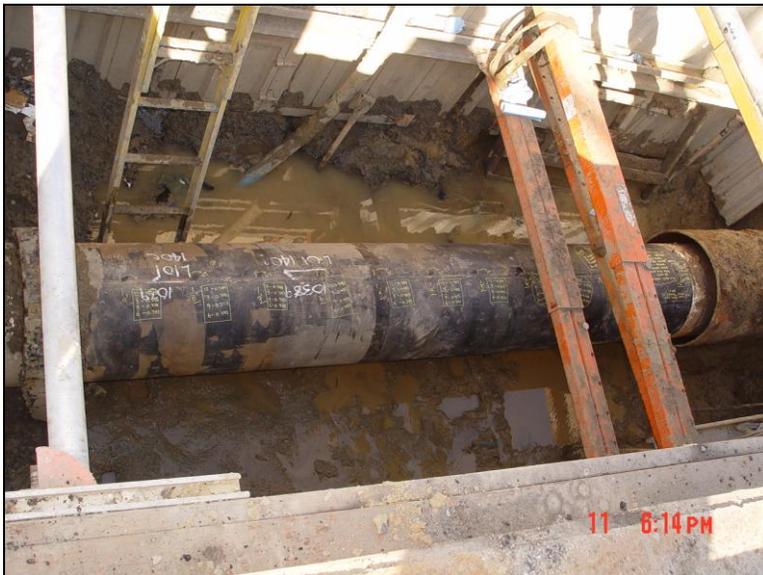
Figure 166. Line after casing removal and direct inspection shows wall thickness measurements and the end of the remaining casing.

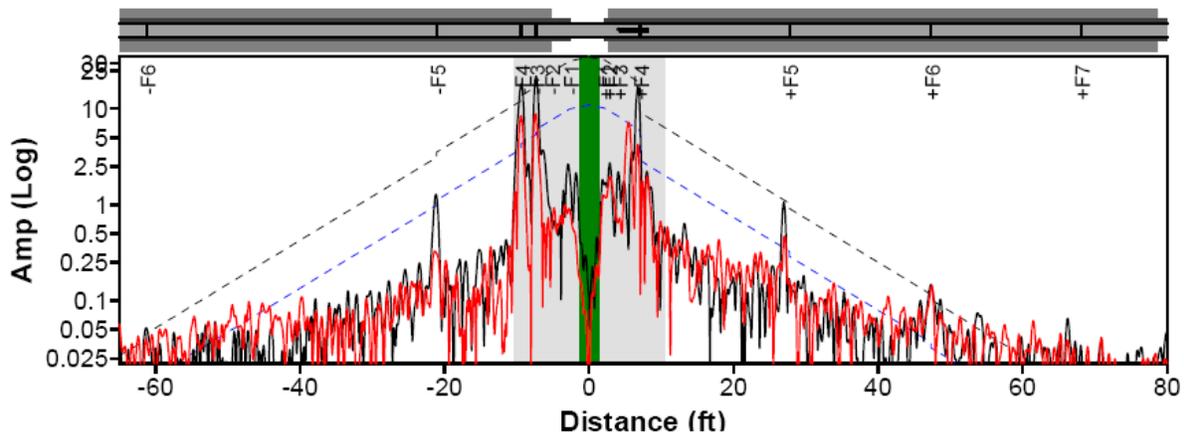
Although the coating is thin, the attenuation was measured at -0.9dB/ft, this is somewhat higher than expected for this kind of wrapping; The increase in attenuation may be associated with the condition of pipe surface(s) and or the properties of the uniform coating. Nevertheless the general signal quality is much better than those obtained from Line L132-200C. This average wall thickness of this pipe was measured to be 0.375" which give tc/tp ratio of less than 1. There are no large reflection that were interpreted to be corrosion above the reportable level but there are a number of reflections from within the sleeve from welds and supports.

Figure 168. Guided Wave Scan for Line L101-140C Segment.

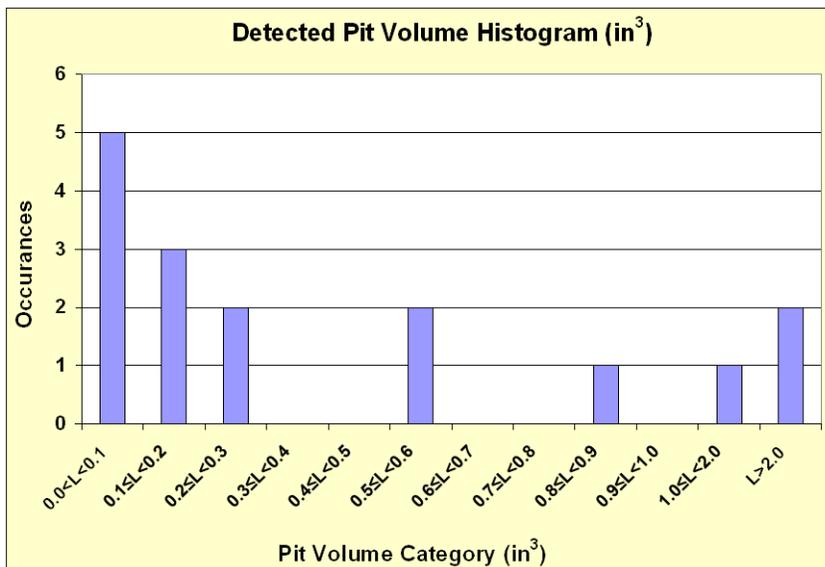
Figure 172. Pit Volume - note that none of these categories are "resolvable" by GWUT yet it predicted the presence of the pits (based on signal-to-noise ratio).

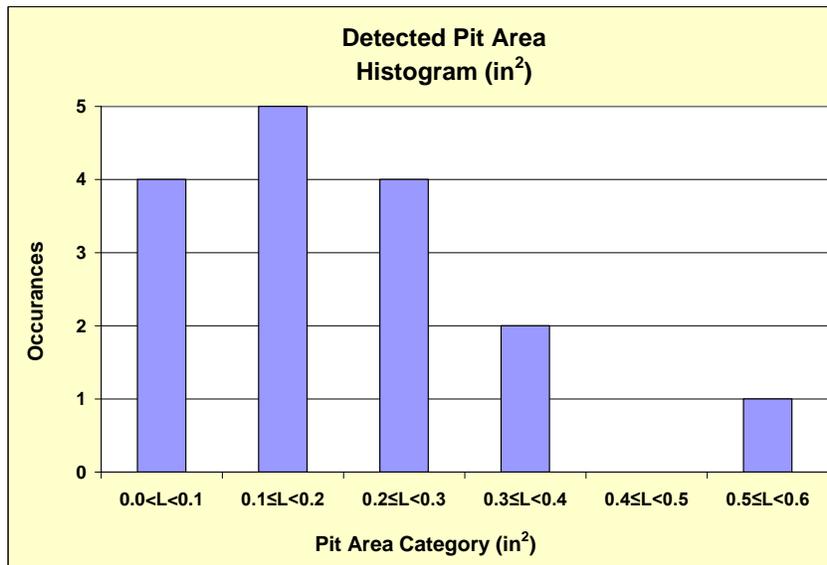
Figure 173. Detected Pit Area - again all categories are less than the typical GWUT wave length yet the pits were predicted.

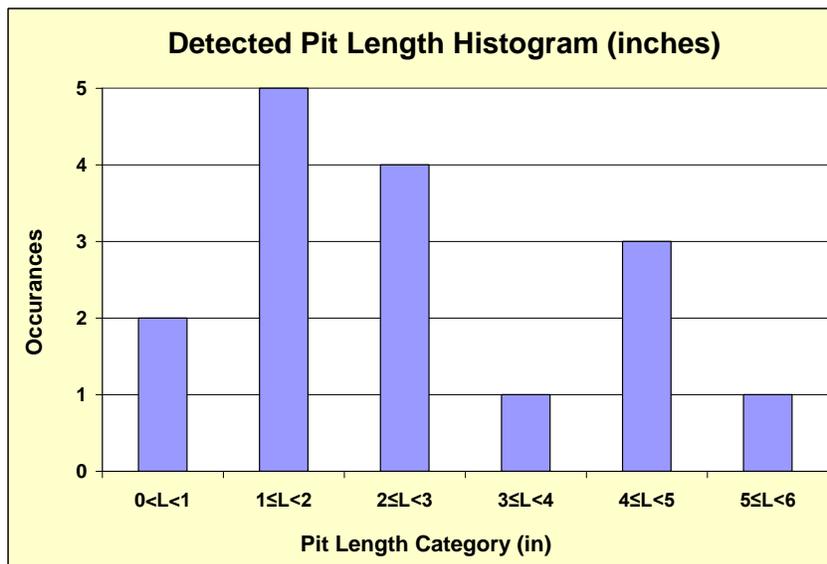
Figure 174. GWUT doesn't actually measure length. Rather the amplitude (over some distance) can indicate if the corrosion area is short medium or longer in length. These show the actual lengths of the indications after excavation, cleaning and measurement.

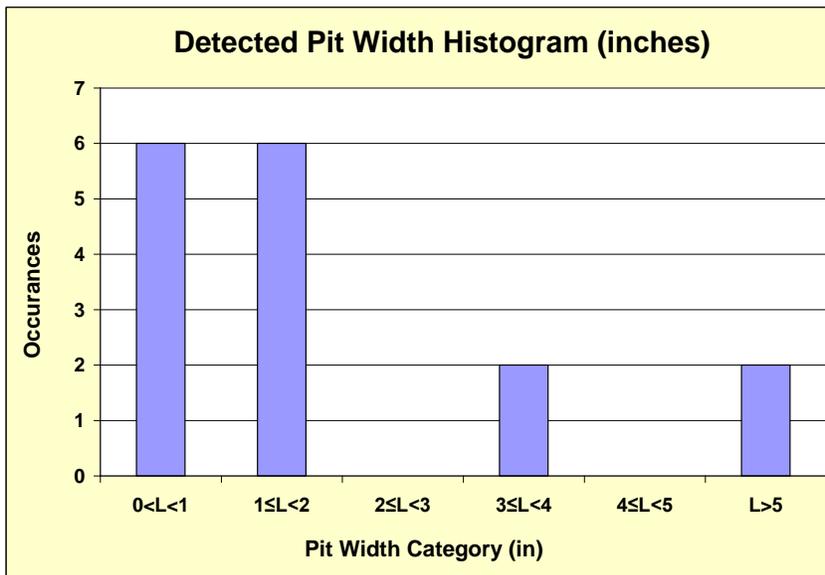
Figure 175. Detected Pit Width - axial width cannot be indicated by GWUT, however the new detection software makes it possible to predict if the corrosion lies in one or more quadrants. In a 24" pipe this width would be around 15 inches.

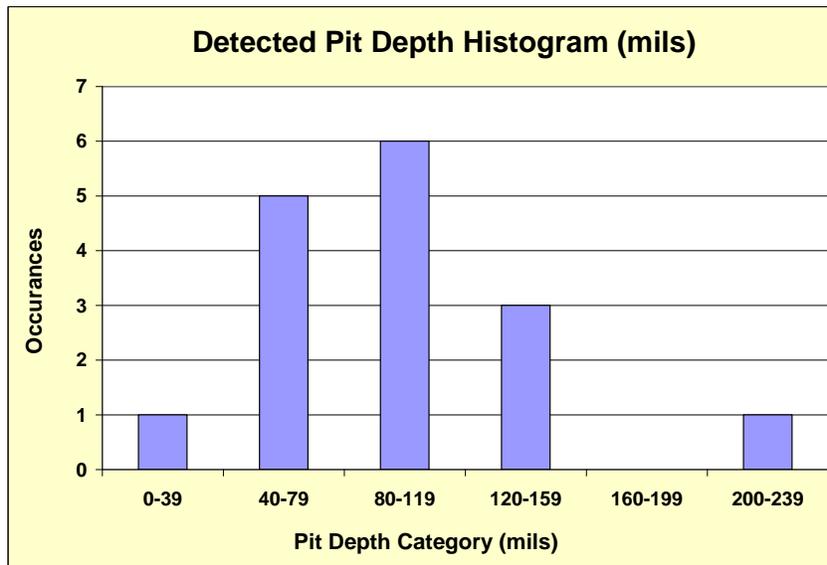
Figure 176. Detected Pit Depth - GWUT was able to find all the deep corrosion. None of these defects failed ASME B31G criteria and therefore all are "monitored" defects that will survive a hydrotest (explained in detail later in the hydrotest equivalency section of this report).

As noted earlier, these depths are much smaller than the associated sound wavelength - so while resolution is impossible, detection is normal.

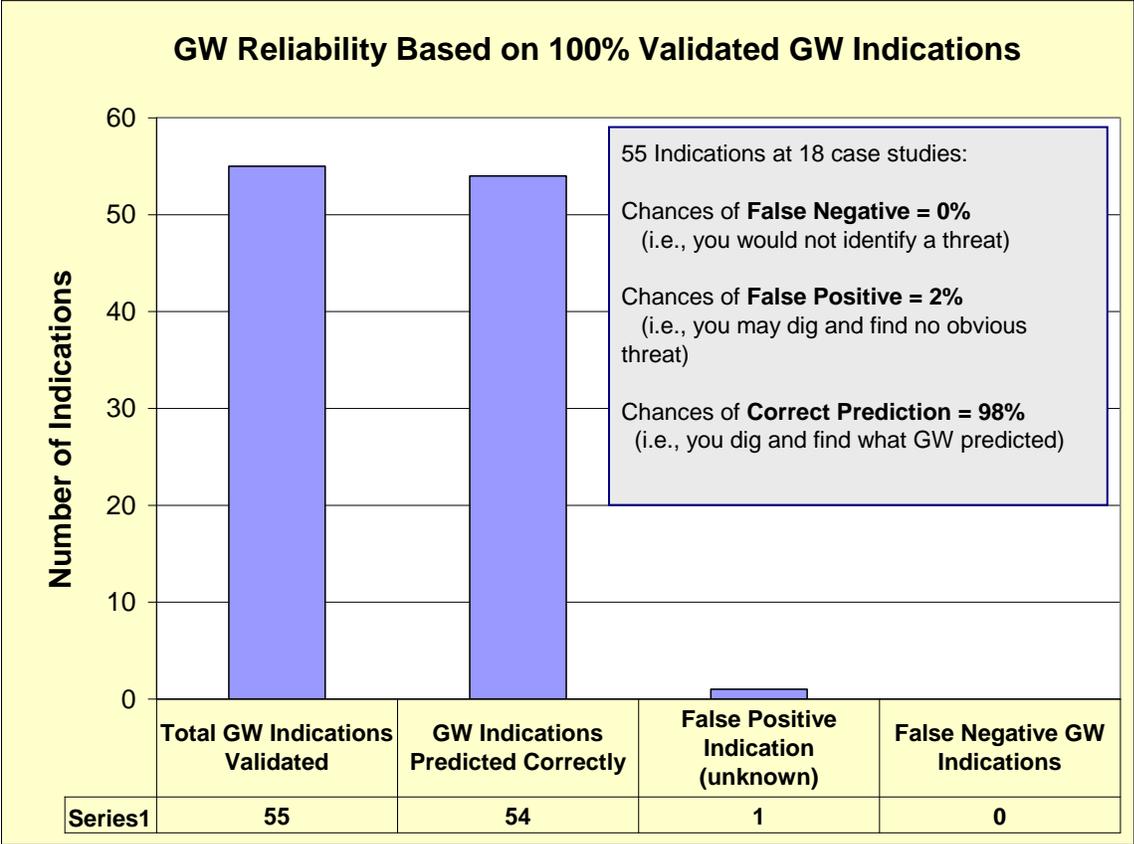
Figure 177. Guided Wave reliability based on 100% validated GW indications (18 case studies - 55 indications; all pipe was uncovered; coating was removed to get to bare metal; further inspection beyond visual was done as necessary, e.g. X-Ray, PortaScan UT, etc.). Note: the lack of any false negatives *includes* all the length of pipe inspected and is a very encouraging result in itself.

The above histograms confirm that GWUT produced very good reliability numbers even though the cases all had very small corrosion damage or none at all. When the casing and coatings were removed, the GWUT operator successfully called all the predictions. No corrosion was found that was not predicted, however one location had corrosion less severe than the prediction, confirming that the tool signals (when interpreted by the current service providers) are basically conservative.
